**Demolition of Dwelling in the Heritage Conversation Area**

**15 Cross St WAGGA WAGGA NSW 2650**

# STATEMENT OF HERITAGE IMPACT FOR:

## THE PROPOSED DEMOLITION OF BUILDING & OUTBUILDINGS AT 15 CROSS ST, WAGGA WAGGA

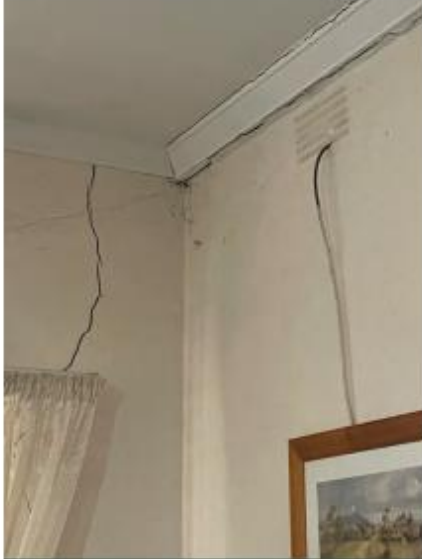
Structural cracking to the lounge room

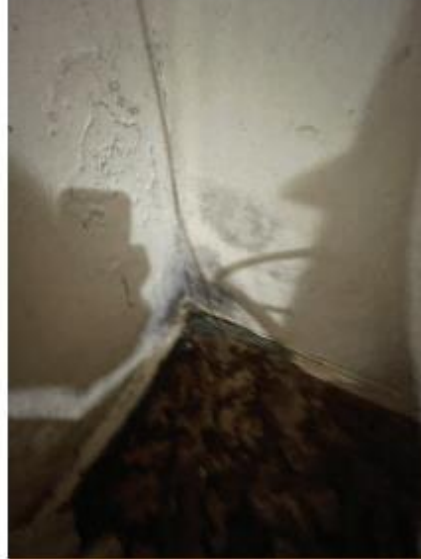
Rising damp and mould to the lounge room

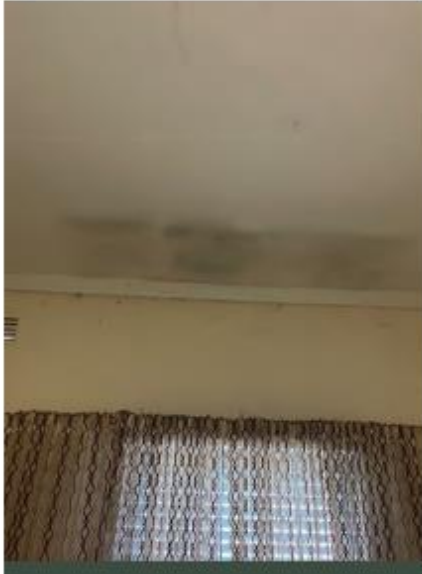
Mould to ceiling

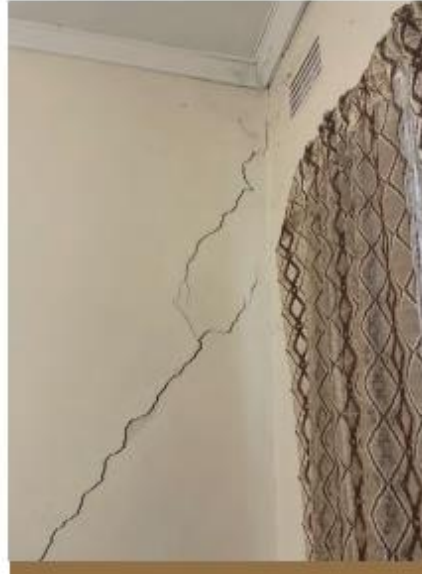
Internal structural cracking to bedroom

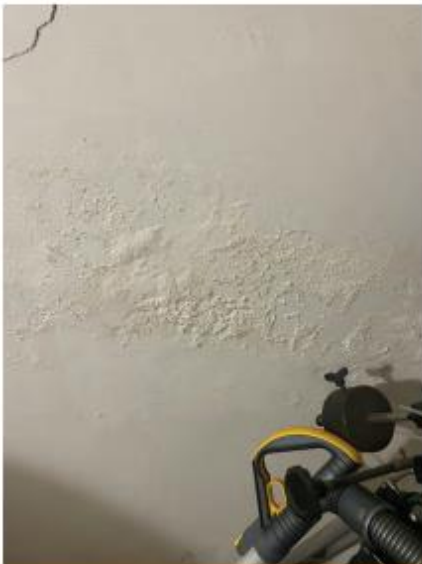
Rising damp

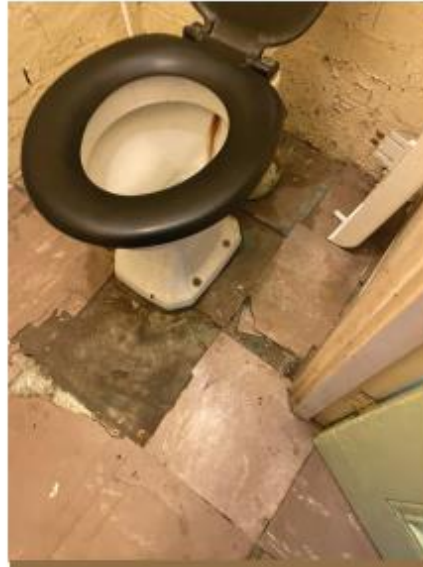
Lifting linoleum floor tiles in WC.

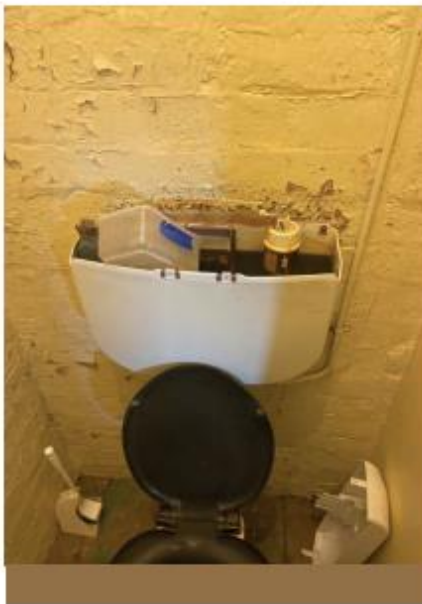
Cistern to WC not functional

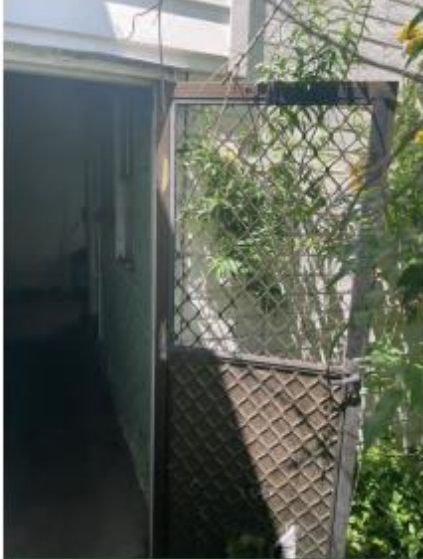
Damaged screen door

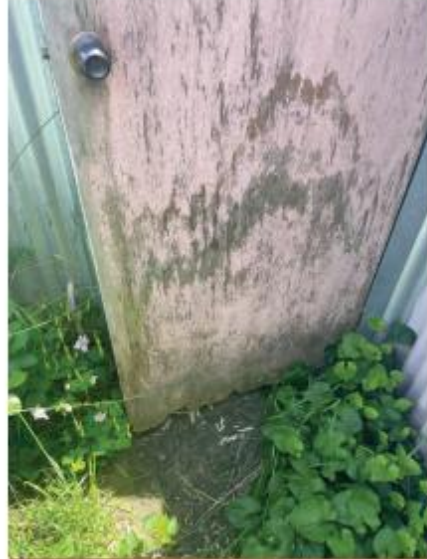
Door to garage requires replacement

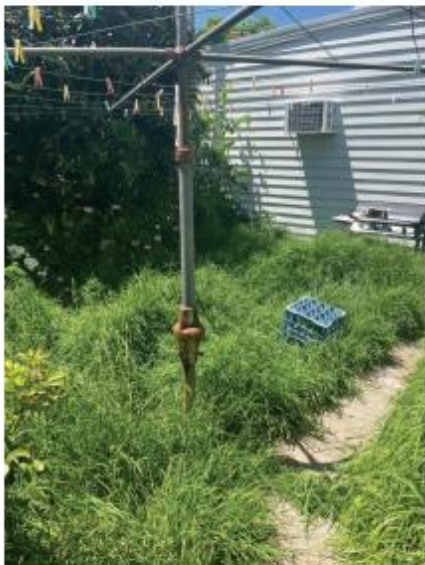
Rear yard overgrown

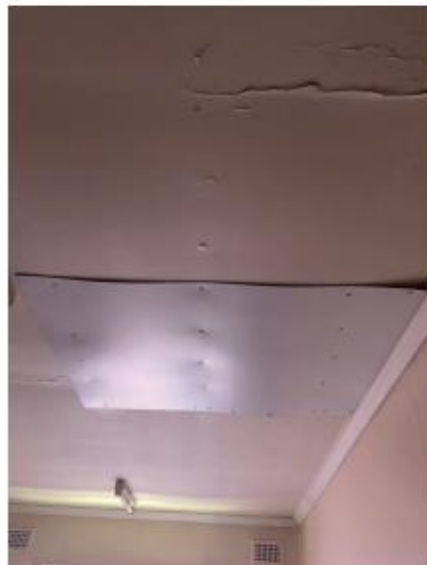
Damaged ceiling in Kitchen 2

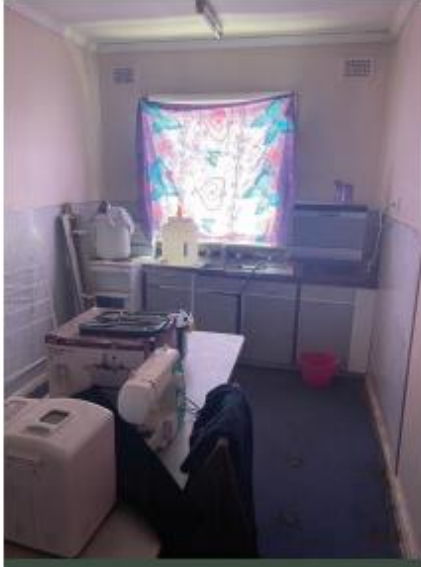
Kitchen requires upgrading

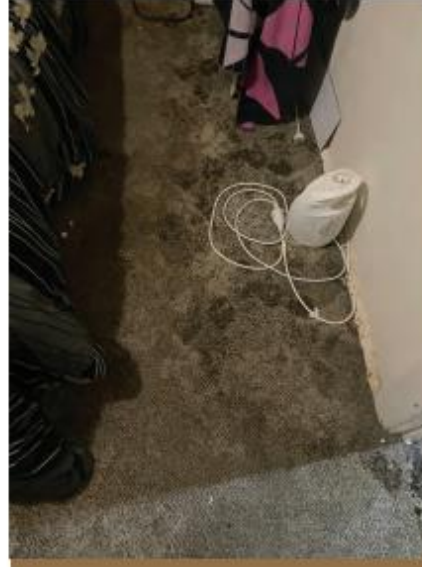
Floor coverings throughout building in poor condition

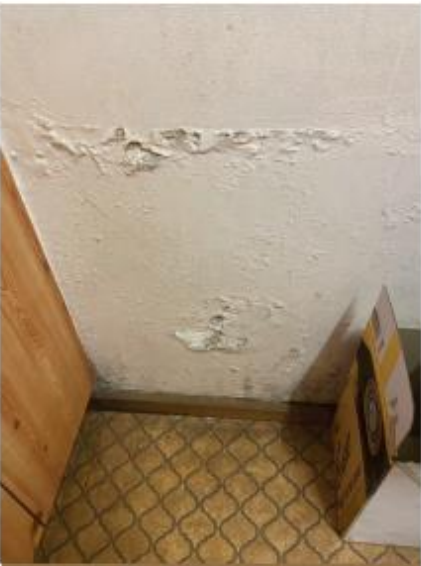
Rising damp in Kitchen

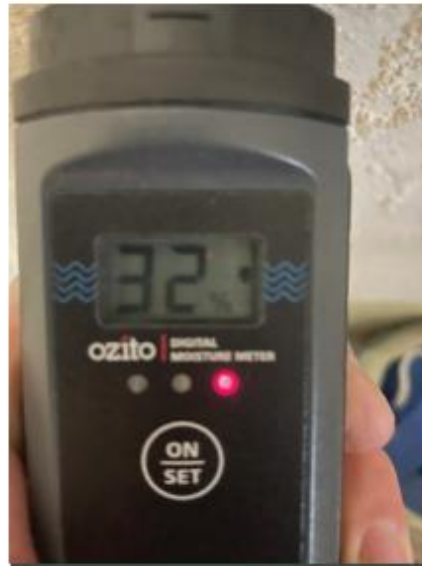
Moisture test of walls. Ranged from 30 to 50 % on some walls

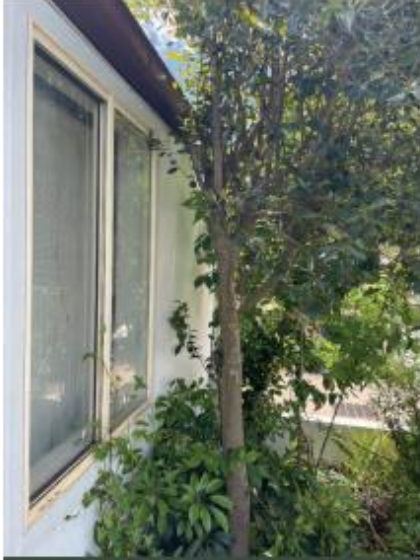
Privet trees growing too close to building need to be removed. Will cause structural damage

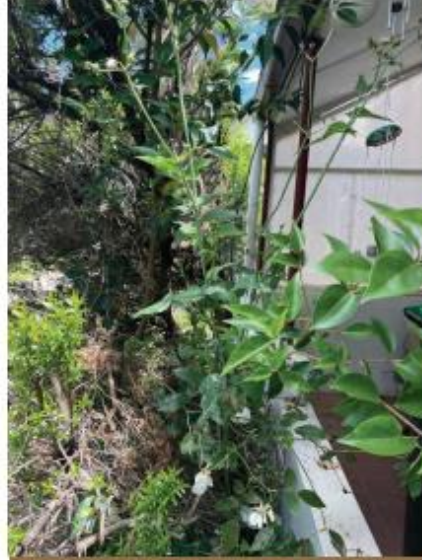
Privet trees growing too close to building need to be removed. Will cause structural damage

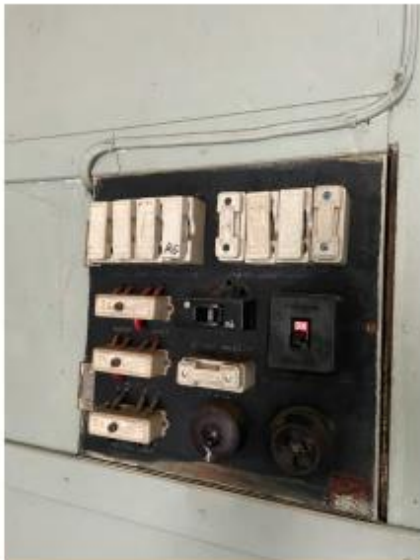
EDB without earth leakage protection

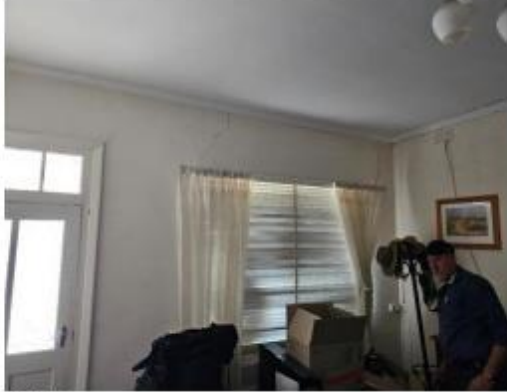
Photo 5

- Cracking of the internal walls, see photos 5, 6, 7 & 8.

There is cracking throughout the heritage listed part of the structure, and this is likely due to inadequate footings in the residence and poor site drainage and moisture control. As the area around the house has been built up over time, there are insufficient falls away from the residence and, therefore, the perimeter surface moisture cannot be drained away from the structure adequately.

The amount of wall movement is up to 25 mm out of plum in a number of locations and, therefore, does not comply with the Masonry Code stability requirements. There are a number of cracks of Category 3, which are considered to be significant and would require structural repair.

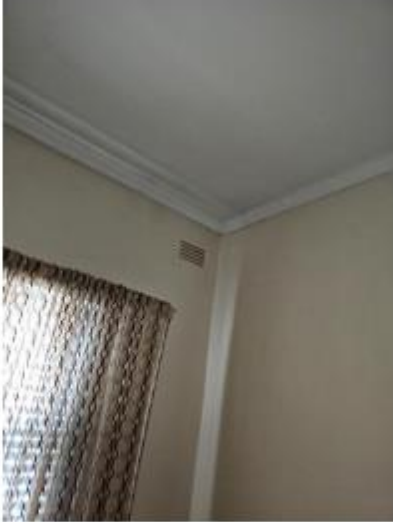
Photo 9

- Cracking of the internal walls, see photos 9, 10, 11 & 12.

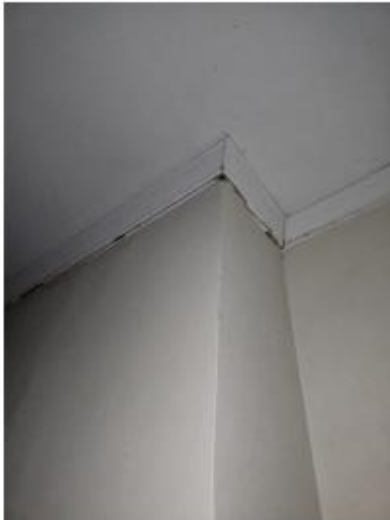
Photo 13

- Cracking of the internal walls, see photo 13.
- Significant rising damp, see photos 14 & 15.

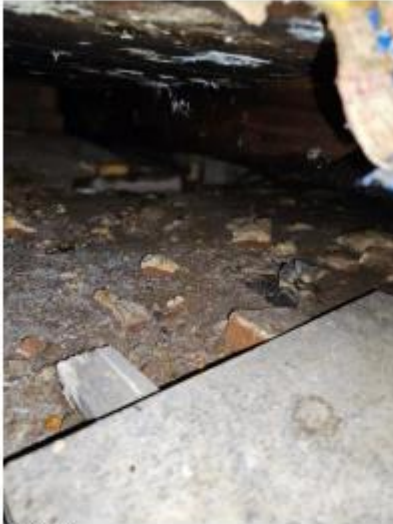
Photo 19

- Inadequate subfloor ventilation, see photo 19.
- This has caused moisture damage to the subfloor, see photos 20, 21 & 22.

There is currently inadequate subfloor ventilation, which is leading to significant rising damp, moisture damage to structural elements, and mould contamination.

- a) There is inadequate subfloor ventilation, and the current timber floor is too close to the ground and does not pass current codes, which has led to the mould problem.
- b) The external surface around the house is too high, and while the vents have been funnelled above the surface level, these are not working, as shown by the current condition and mould.
- c) The damp proof course is not functional.
- d) Deficiencies in the site drainage.

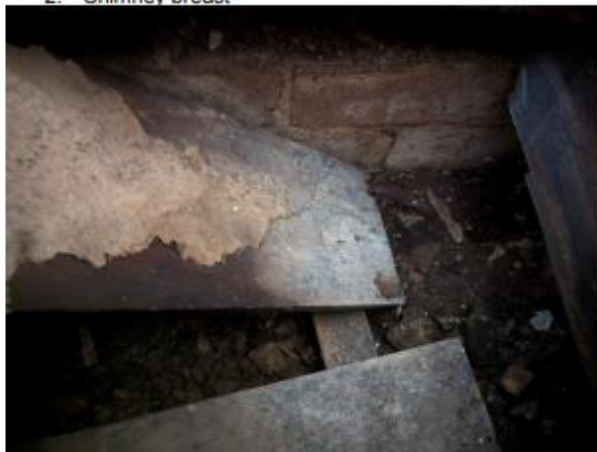
3. View into minimal sub-floor area. Engineering advice will determine whether this can be conserved as a ventilated sub-floor with steel joist construction or a concrete slab replacement installed.

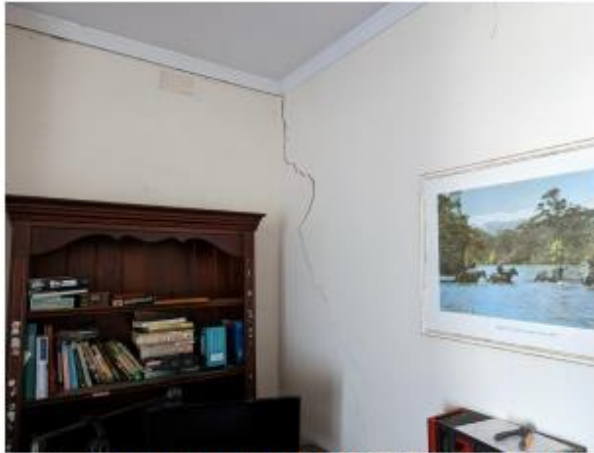
4. Primary cracking to the rear corner. Following a solution for a floor, Helifix can be installed to repair this damage.

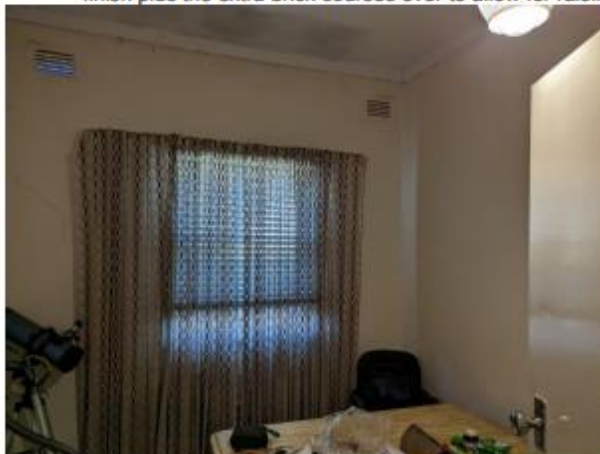
19. Room with window and mould on the ceiling.

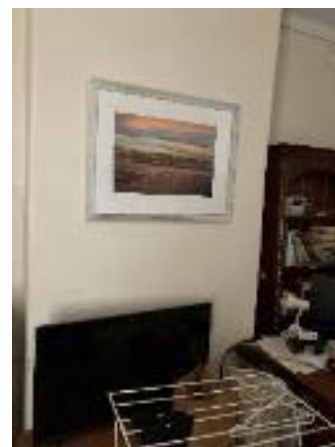
Cottage - front living room cracking

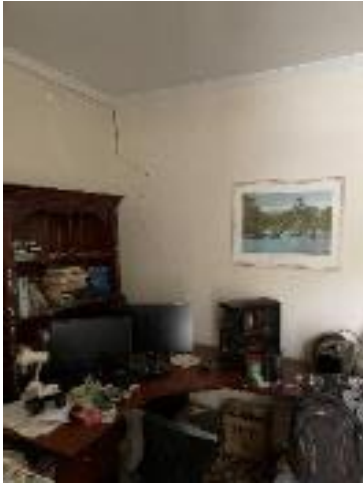
Cottage - front living room cracking
