**Demolition of Dwelling in the Heritage Conversation Area**

**15 Cross St WAGGA WAGGA NSW 2650**

# STATEMENT OF HERITAGE IMPACT FOR:

## THE PROPOSED DEMOLITION OF BUILDING & OUTBUILDINGS AT 15 CROSS ST, WAGGA WAGGA

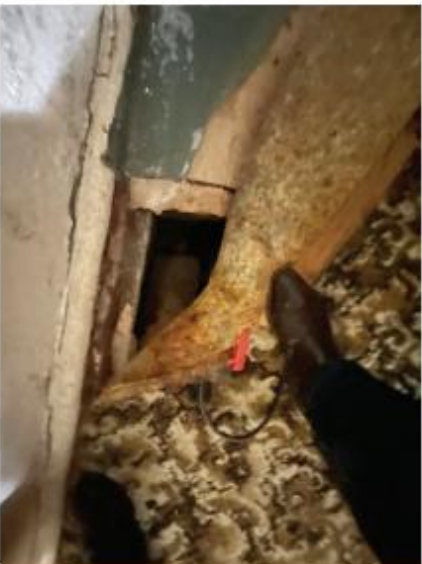
Rotten flooring in the lounge room. Sub floor is approximately 200mm below floor height and is saturated with ground water.

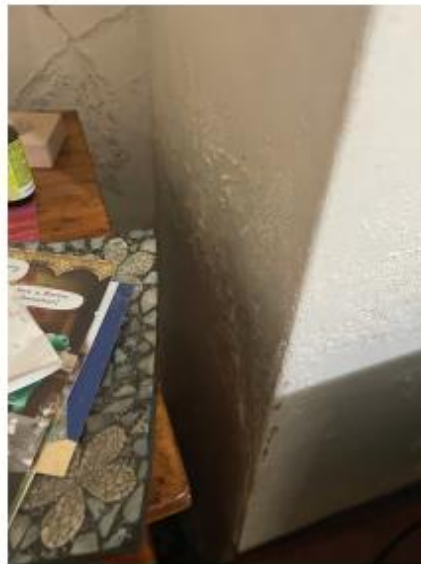
Rising damp to Lounge room walls

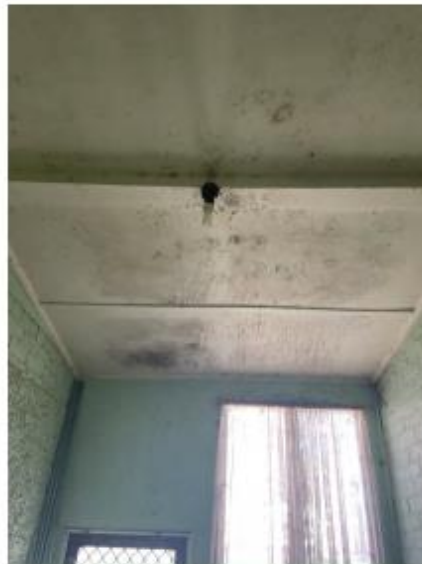
Mould to ceiling in rear room

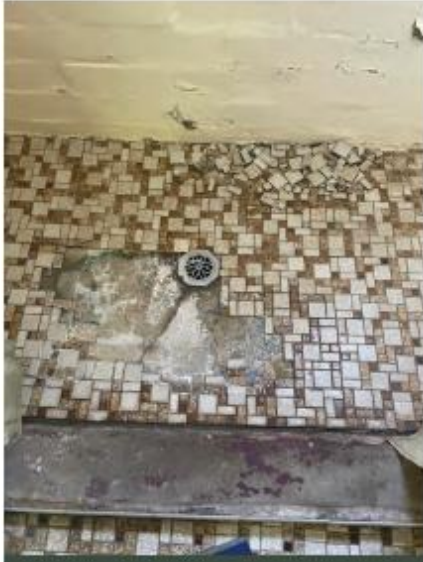
Lifting floor tiles to shower

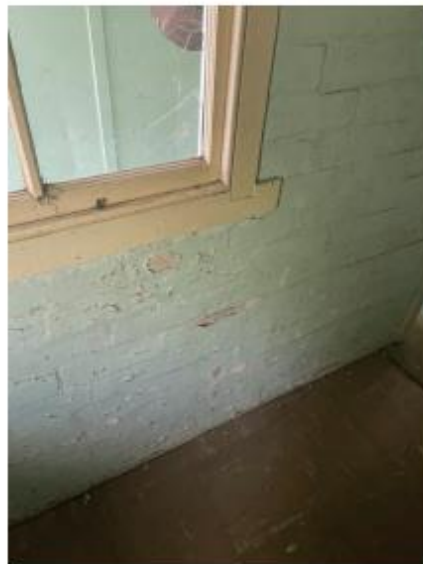
Peeling paint to rear room, probably contains lead

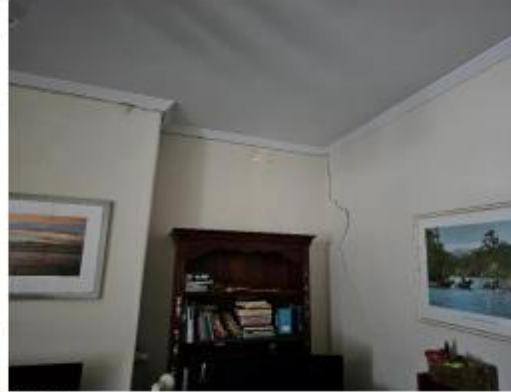
Photo 6

- Cracking of the internal walls, see photos 5, 6, 7 & 8.

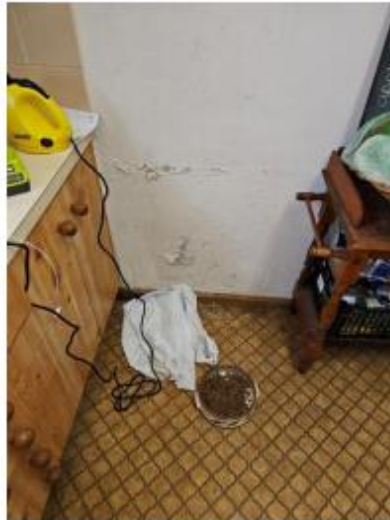
Photo 14

There is currently inadequate subfloor ventilation, which is leading to significant rising damp, moisture damage to structural elements, and mould contamination. This dampness and mould are at least due to the following:

- Cracking of the internal walls, see photo 13.
- Significant rising damp, see photos 14 & 15.

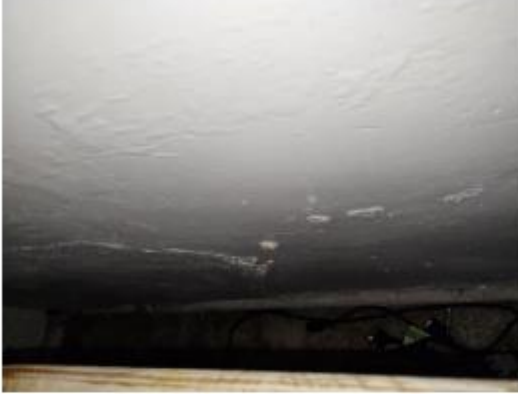
Photo 16

- Significant rising damp, see photos 16, 17 & 18.

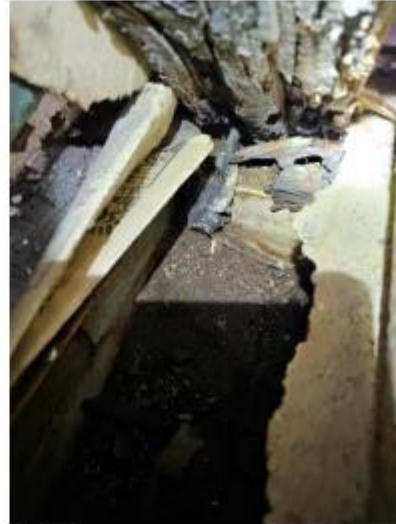
Photo 20

- Inadequate subfloor ventilation, see photo 19.
- This has caused moisture damage to the subfloor, see photos 20, 21 & 22.

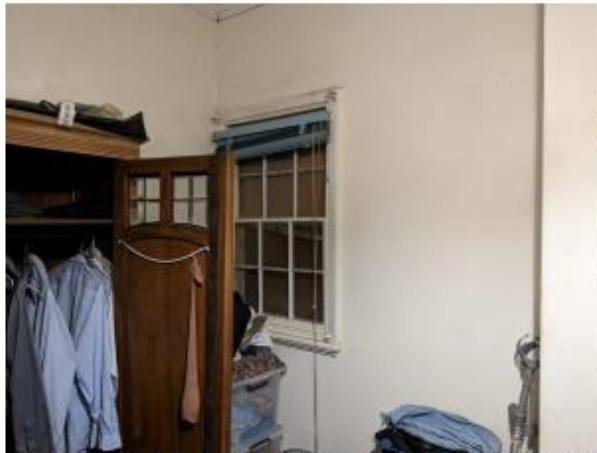
1. Room to the Lane side with original fine DHSS window

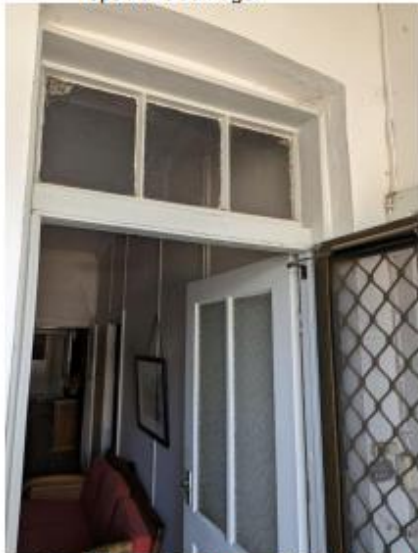
5. The original door opening with frame and joinery and highlight

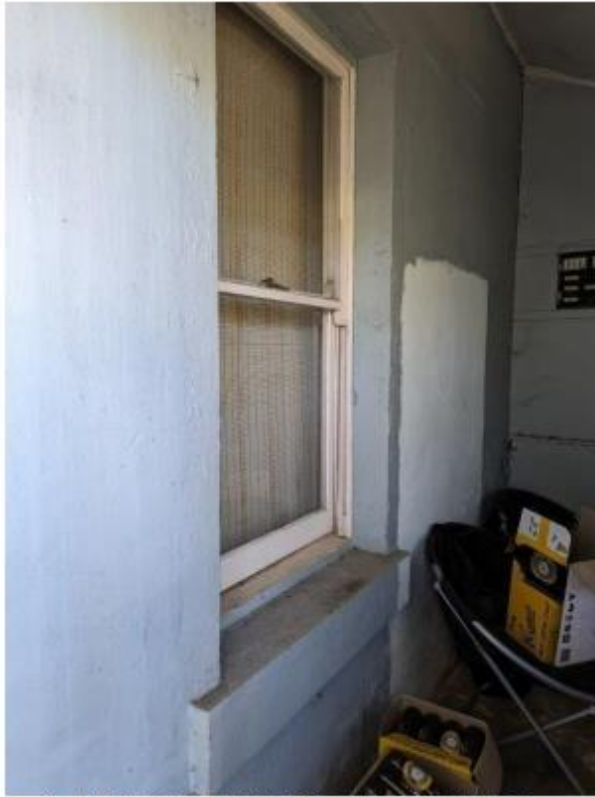
6. A replacement DHSS with rendered wall and sill

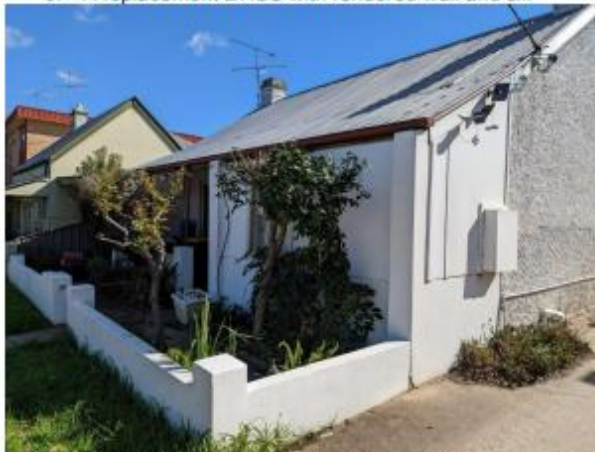
7. General view of the front corner noting the verandah enclosure, front low wall and galvanised iron roof with two chimneys. This wall is on the Lane boundary.

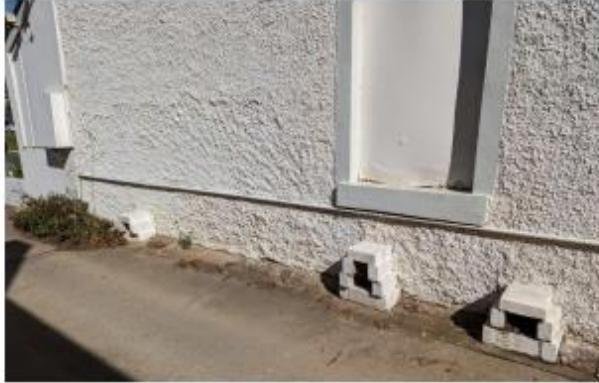
8. Previous treatments using ventilation of the sub-floor.

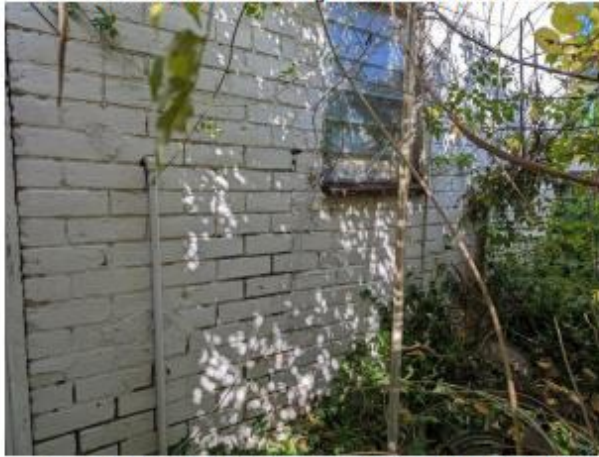
9. The later stretcher bonded brick to the rear laundry/toilet block indicates this is a later stage of the property -possibly the flat conversion period.

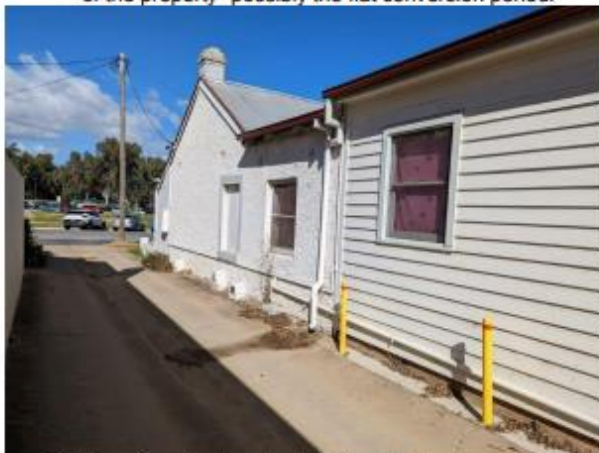
10. View from the Lane looking towards the frontage showing the original and extension elements. Windows if retained on the boundary wall will need treating to meet the BCA conditions.

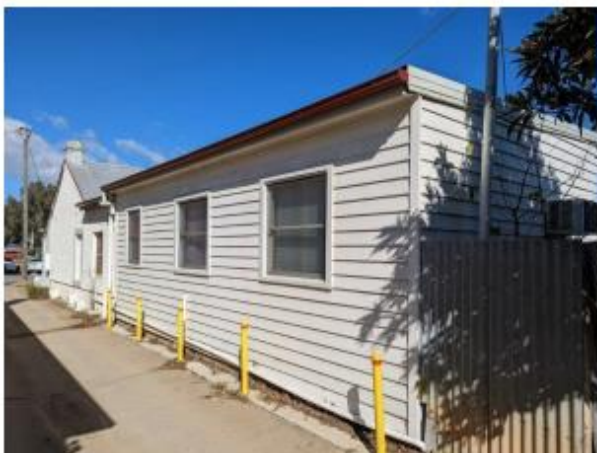
11. General view of the later flat dwelling extension. The period and style would not indicate a level of significance to warrant retention. Demolition and replacement would be supported.

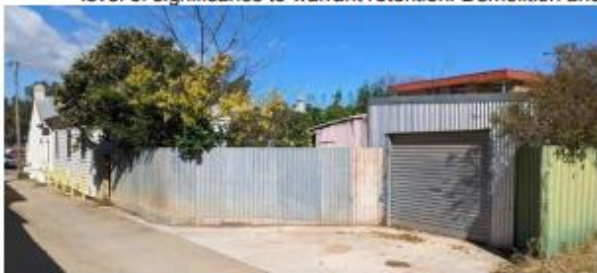
12. The rear yard and galvanised steel garage/shed

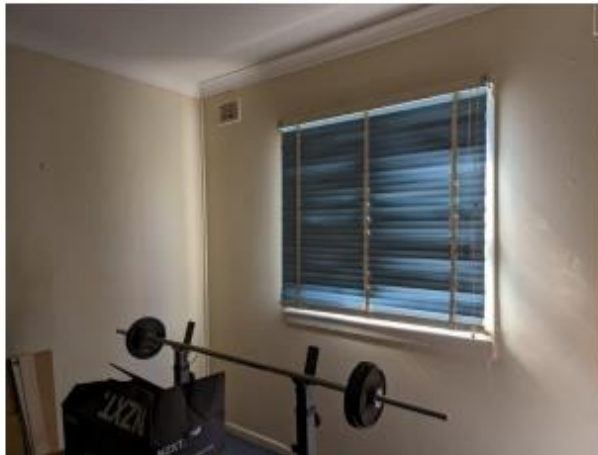
14. A replacement window is evident in this front room.

- Replacement traditional DHSS windows may be installed to replace those out of keeping while the originals may be retained and located to suit a layout

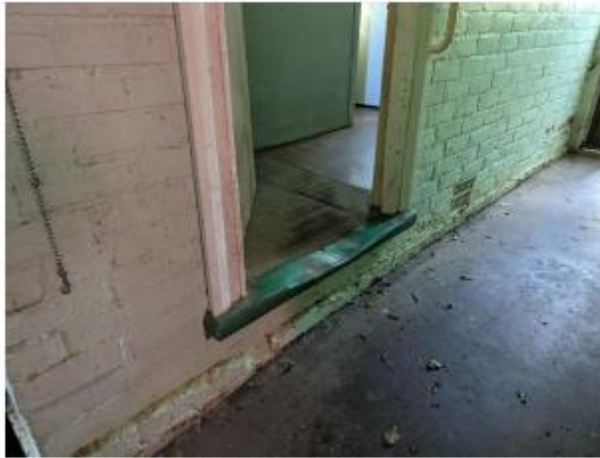
17. The end of the early cottage is evident with the rear threshold and brickwork

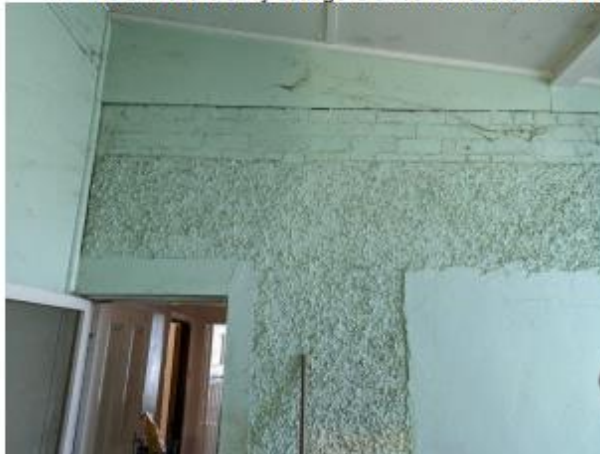
18. A portion of the rendered wall and the door to the main passage. The wall is in a roughcast finish plus the extra brick courses over to allow for raising of the roof

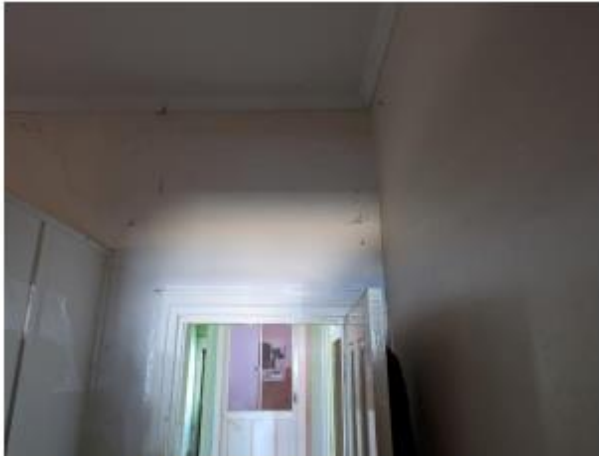
20. Early door and joinery from main passage

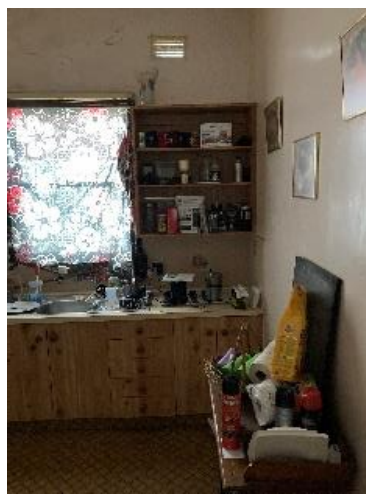
Cottage - kitchen

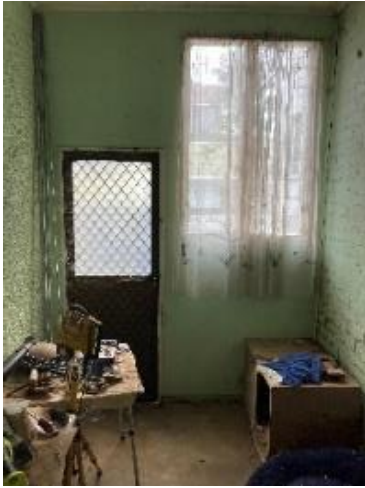
Cottage - new wall to separate rooms

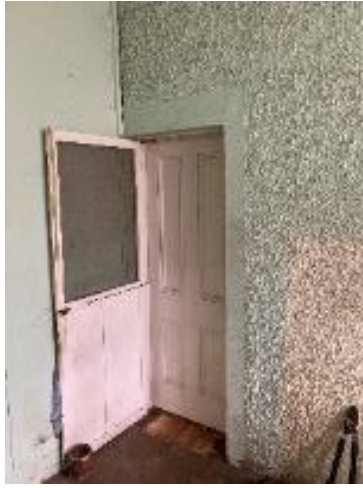
Rear infill area between the cottage and house extension and toilet/laundry block addition

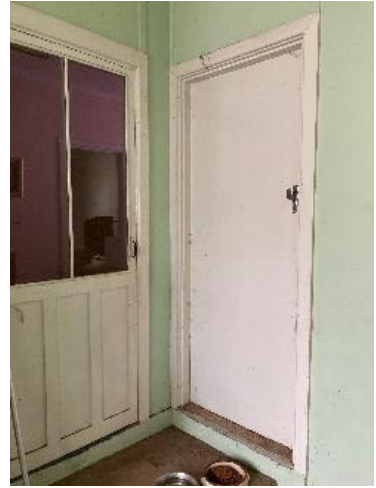
Access to rear yard – conc path

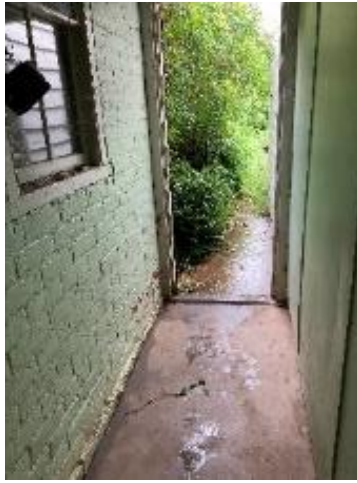
'Corridor' between extensions

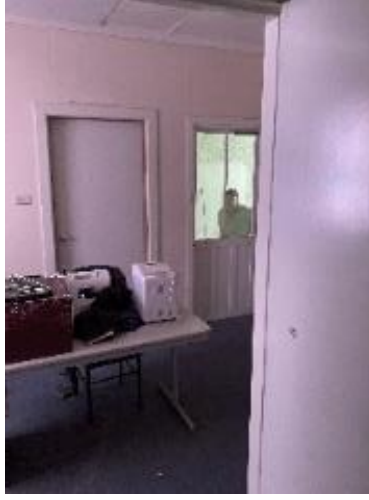
Extension – kitchen

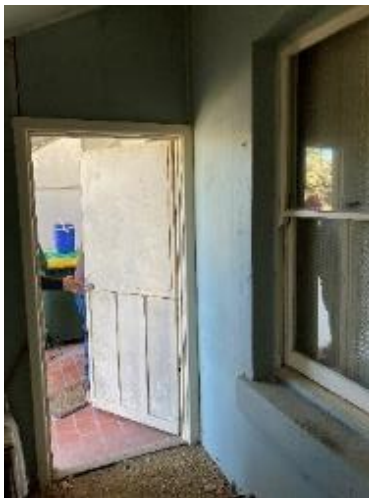
Cottage – infill verandah - storage room
